Expert's Preliminary Written Report
By Captain Jay Rivera
In the matter of:

**MODA INGLESIDE OIL TERMINAL, LLC
vs.**

**RIVERSIDE, its engines, tackles, etc., in
rem, et al.**

**UNITED STATES DISTRICT COURT
SOUTHERN DISTRICT OF TEXAS
CORPUS CHRISTI DIVISION**

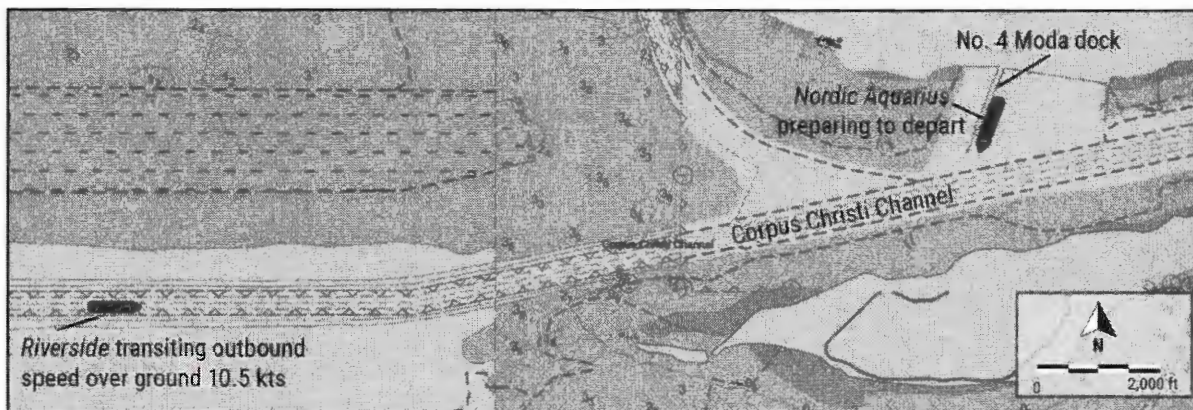
Figure 1
General Area of Incident. Diagram from NTSB Investigation Report

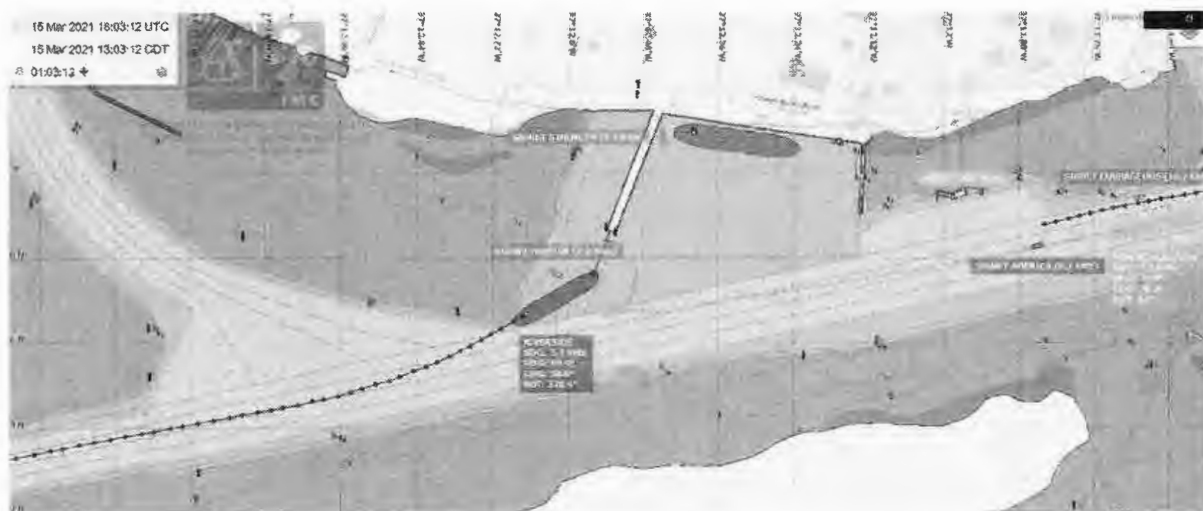
The NORDIC AQUARIUS was berthed at MIEC dock 4, on the East side of the MIEC finger pier. The RIVERSIDE's main engine failed to restart after multiple attempts and the vessel eventually allided at about 1302 local time, with the MIEC finger pier that comprised both loading berths 4 and 5. No pollution or injuries were reported. The RIVERSIDE sustained some damage to its port side and the facility sustained considerable damage. MIECs pier was left inoperable and required extensive repairs.

Figure 2
Diagram of allision with MIEC Pier. From Thome Ship Management Incident Report
